ROOF AUDIT & **RESERVE STUDY**

**10220 HARNEY ROAD
THONOTOSASSA, FL 33592**

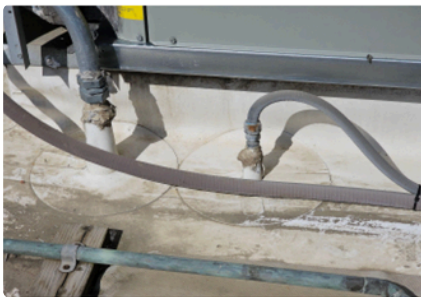
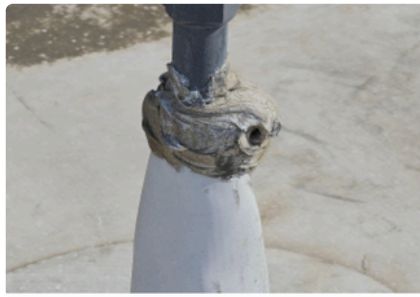
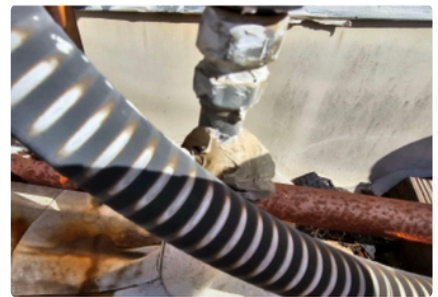
1. The roof penetrations collars have been previously sealed caulking. The caulking is cracking and should be resealed in order to maintain a water tight condition. Recommendation- As necessary , reseal roof penetrations. All repairs will be made with high grade polyurethane roof sealant.

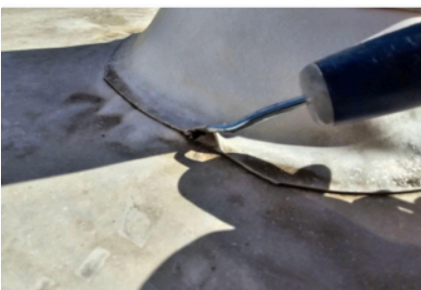
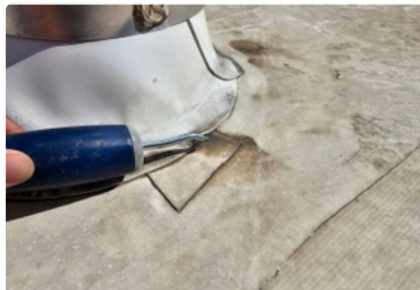
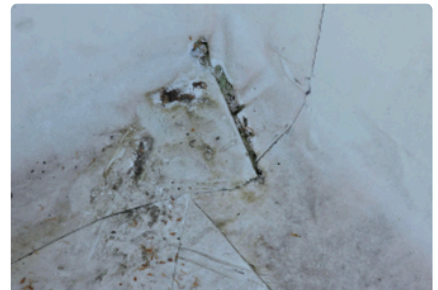
2. Seams were noted to be open or not properly welded. This condition could allow water to enter this/these areas in a hard wind driven rain. Recommendation-Clean defected areas with weathered membrane cleaner. Heat weld/patch with like materials or apply liquid flashing.

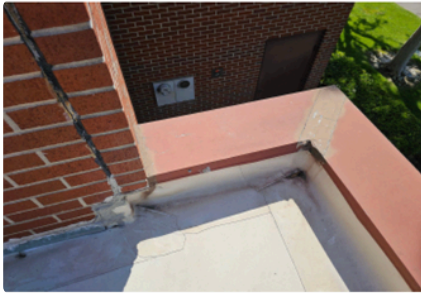
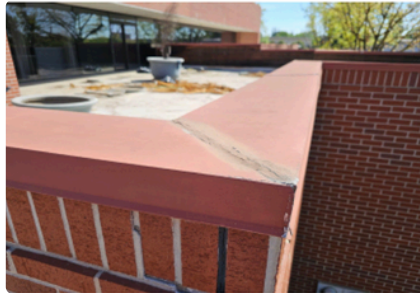
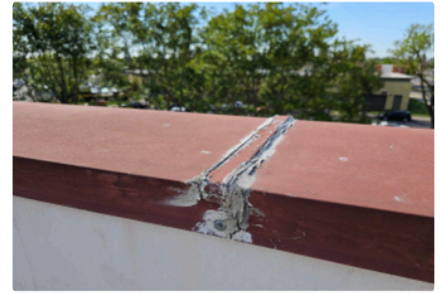
- 3.** The sealant used to seal the parapet metal trims are cracking/deteriorating. These condition will allow water to enter the building at these areas. Recommendation-Install cap metal at missing cap section only. Clean and remove old sealant as necessary. Refasten laps if necessary. Seal all laps with high grade polyurethane roof sealant.

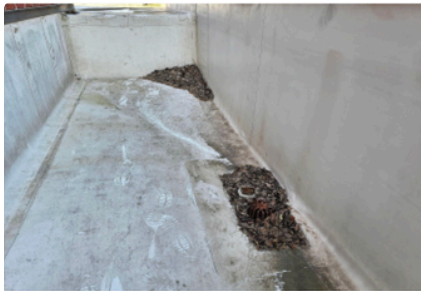
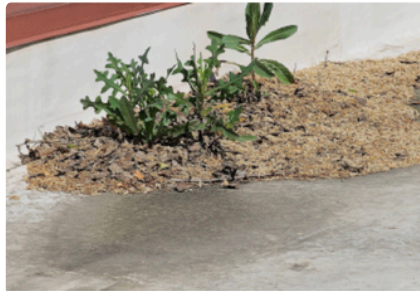
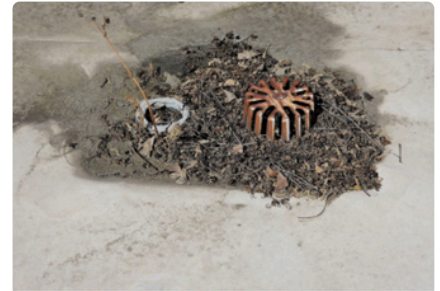
- 4.** There is debris on the roof surface that is blocking proper water flow throughout the roofing system. Recommendation- Clear all roof debris and dispose of off site.

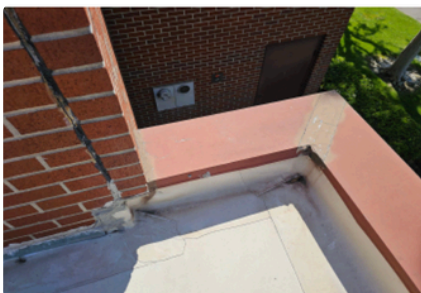
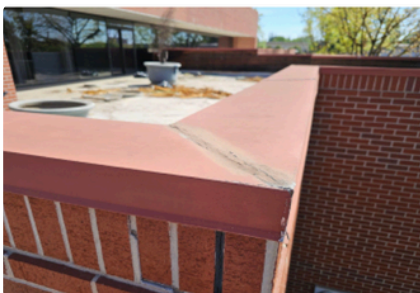
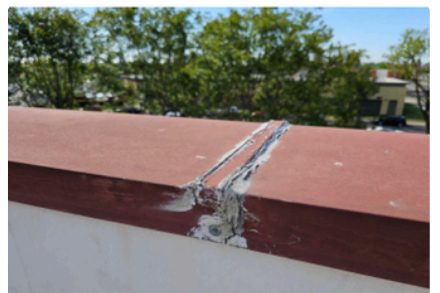
- 5.** The sealant used to seal the parapet metal trims are cracking/deteriorating. These condition will allow water to enter the building at these areas. Recommendation-Install cap metal at missing cap section only. Clean and remove old sealant as necessary. Refasten laps if necessary. Seal all laps with high grade polyurethane roof sealant.
